NASA General Working Paper No. 10,023

RESULTS OF THE APOLLO I CENTRIFUGE PROGRAM
(ENGINEERING DEVELOPMENT AND PILOT FAMILIARIZATION)

NATIONAL AERONAUTICS AND SPACE ADMINISTRATION
MANNED SPACECRAFT CENTER

March 9, 1964

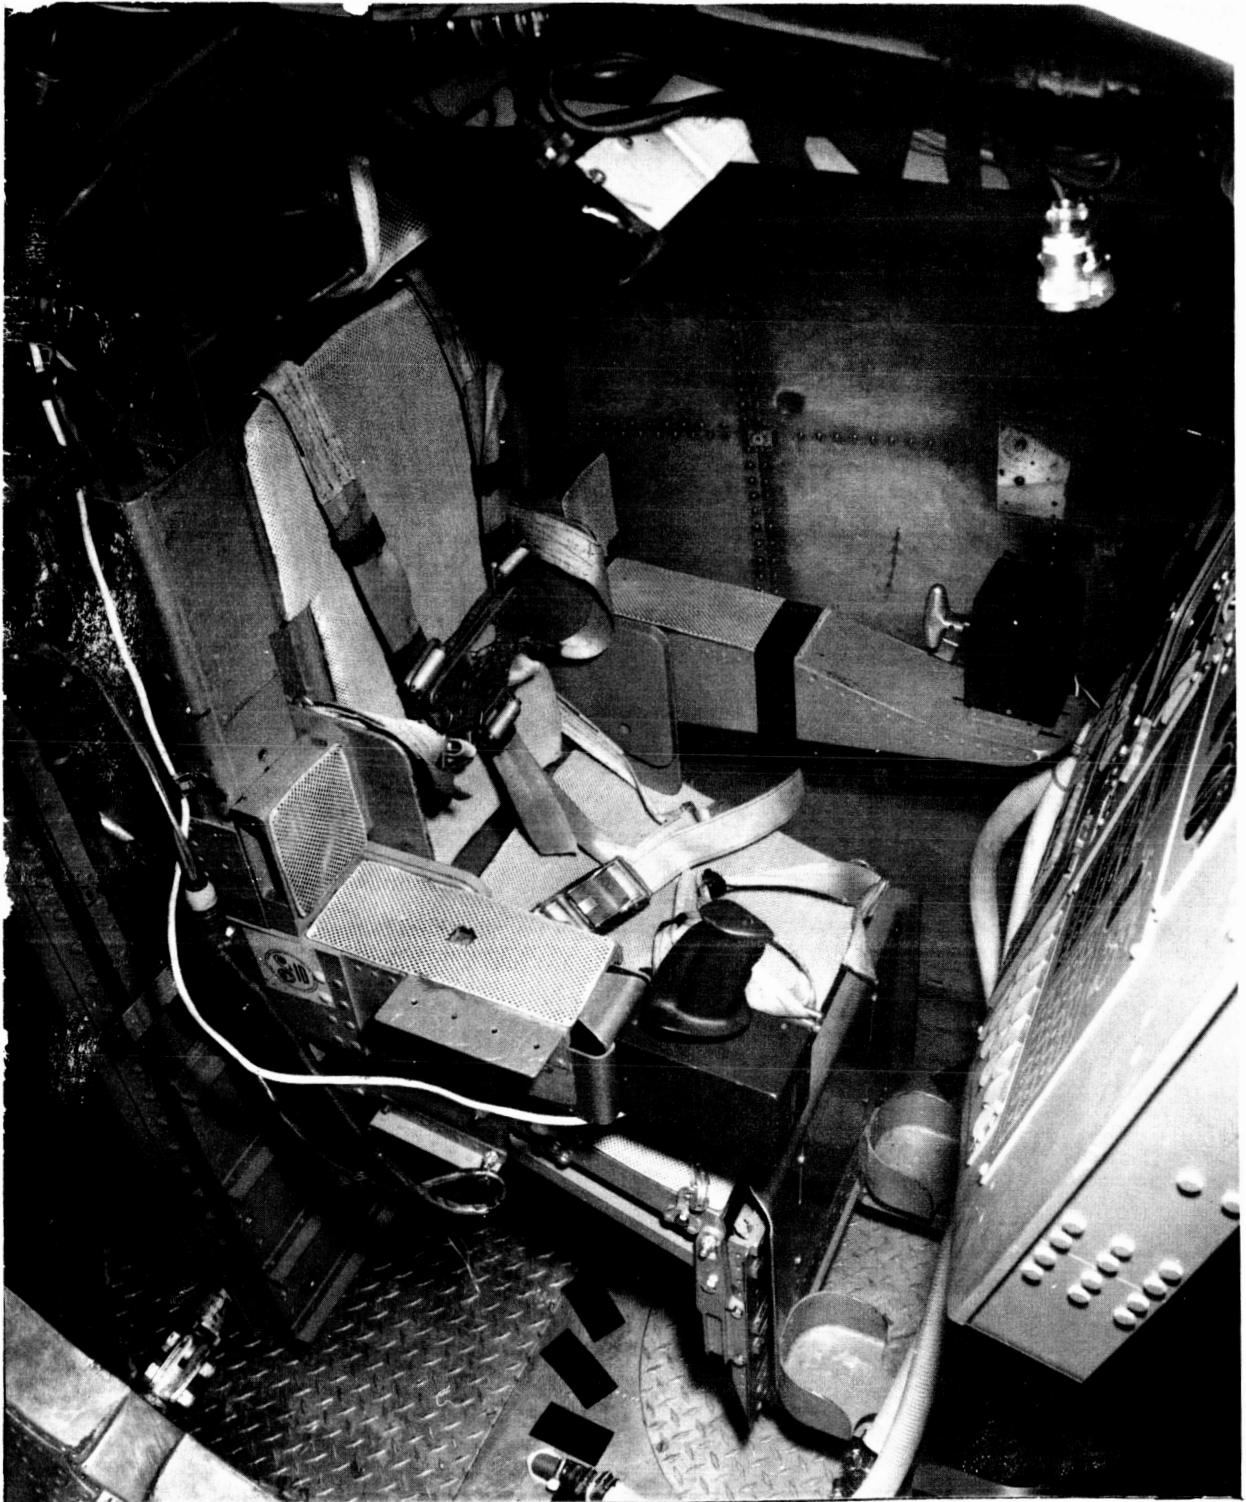
The couch interface to suit and harness was spacecraft configuration. Figure 1 is a photograph of the centrifuge installation. All runs were made with the couch hip and knee angles at 108° and since this proved to be acceptable, no further changes were made.

**FIGURE 1: CENTRIFUGE COUCH AND
RESTRAINT SYSTEM**

Minneapolis-Honeywell hand controllers were used in the program. (See fig. 1.) The left hand (translation-abort) controller was fixed in all axes except for the abort (rotational) movement. The right hand (attitude) controller incorporated all switches inside the handgrip. This controller was canted to fit the natural hand position of the command pilot, the neutral position being 10° forward, 7° off vertical to the left and rotated 7° to the left. When the attitude controller was deflected out of detent $\pm 3.25^\circ$ in the roll direction during automatic entries, the pilot overrode the automatic system. Full throw of the controller ($\pm 13^\circ$) provided the direct mode of operation, while a deflection of 3.25° to 13° resulted in rate command. Therefore, the pilot could override the auto-pilot with either rate command or direct depending on how much roll he commanded. Full rate command roll was $17^\circ/\text{second}$.

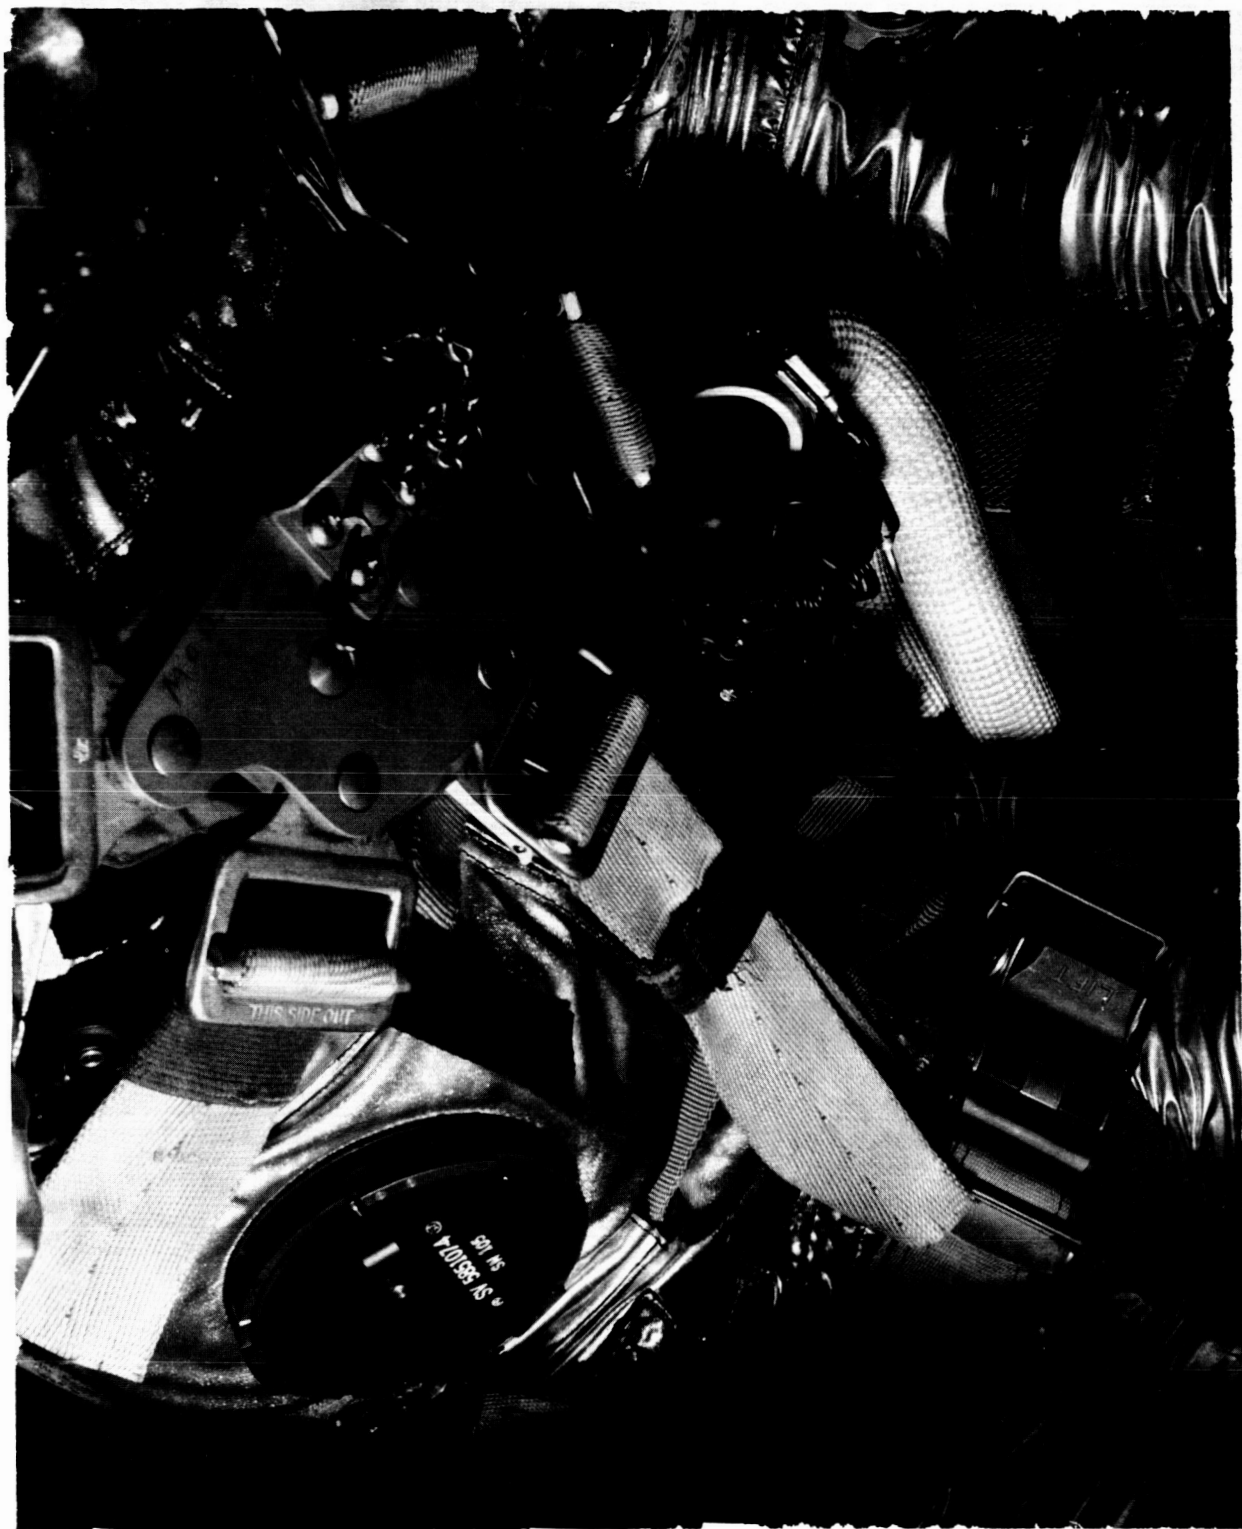
The restraint harness used was of the five-point-release design. (See fig. 2.) The chest buckle, which weighed approximately 1.4 pounds and had an area of 20 square inches, constituted the five point release by joining the two shoulder straps, the two chest straps, and the crotch strap together. In addition to these, there was a hip and lap belt combination which fastened in the middle by means of an aircraft type buckle. The legs were restrained by a leg strap about 6 to 8 inches above the knees, and the feet were restrained by means of metal foot-pans. During the program, various forearm and elbow restraints were devised and tested.

FIGURE 2: RESTRAINT HARNESS CHEST BUCKLE

3. The inverted metal "V" at the hips, where the hip and lap belt tie together, caused pressure points on both sides.
4. The added weight of the chest buckle was tiring and made respiration difficult. It should be eliminated. A strap arrangement in this area would be desirable.

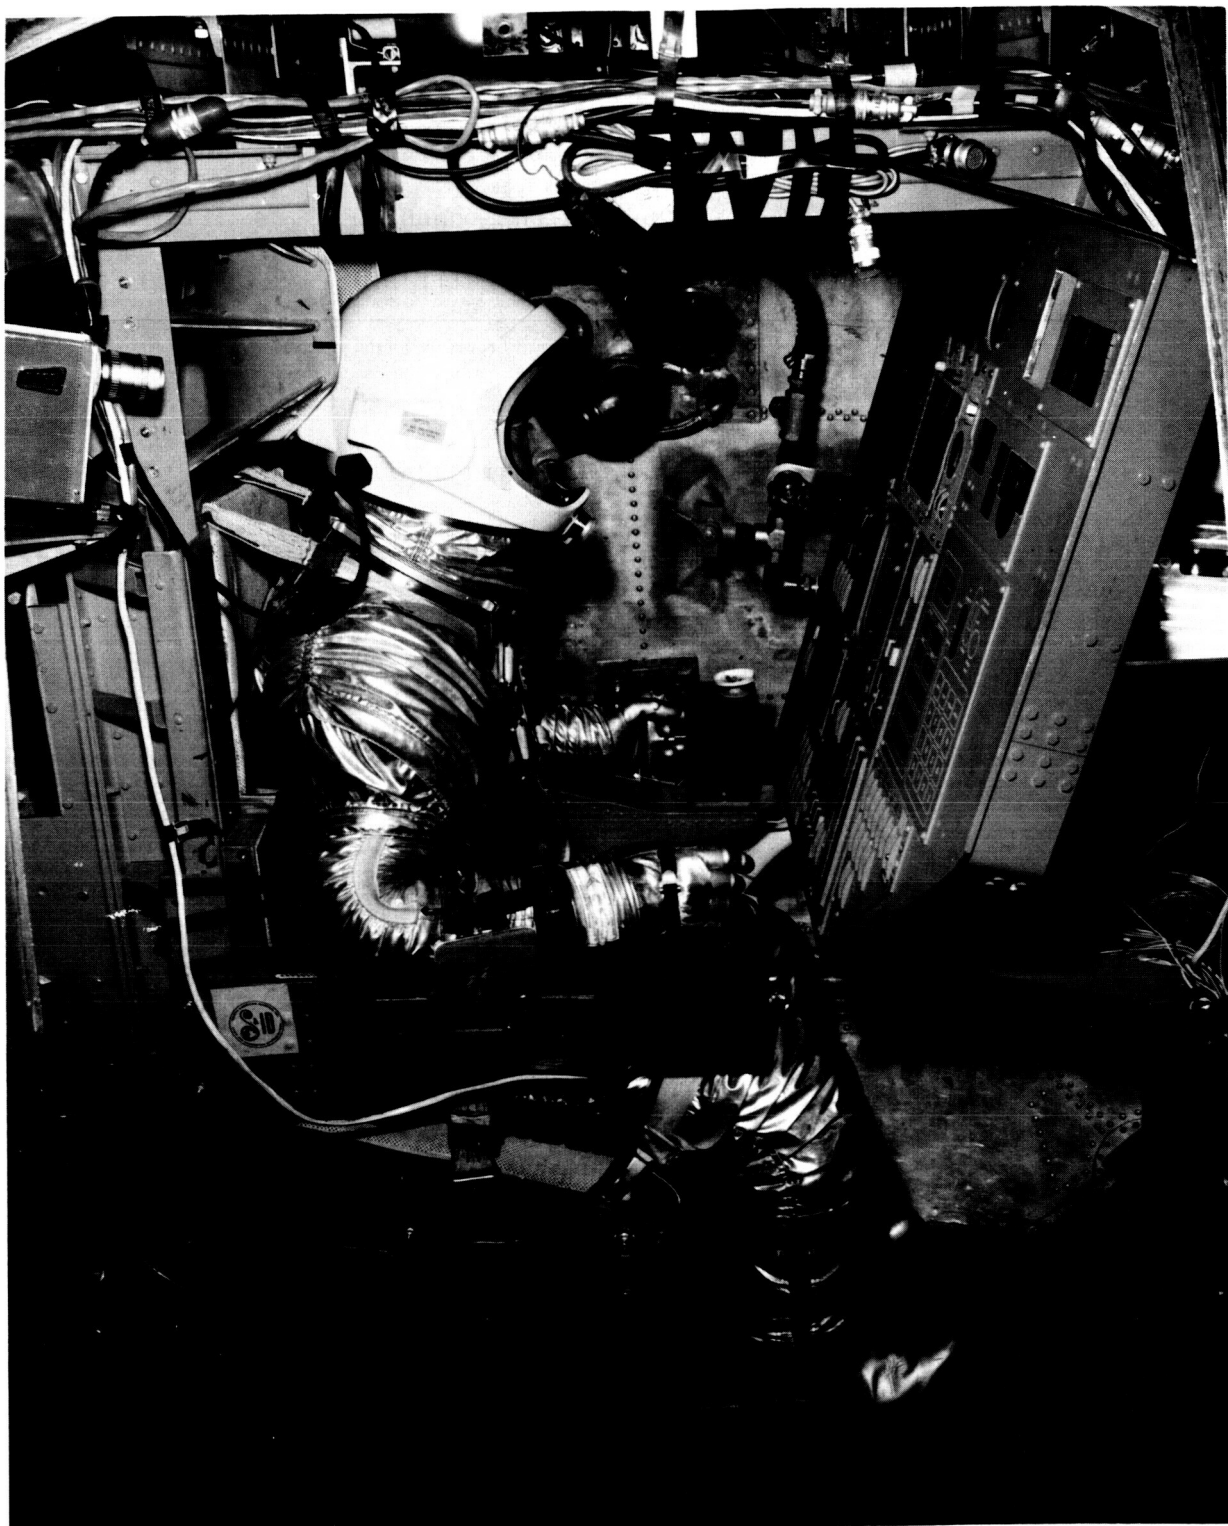
The primary pressure suit used in this program was the second prototype Apollo phase B suit which was the latest design at the time of the program. (See figs. 3 and 4.) A noticeable feature on this suit is the emergency oxygen supply box located on the back of the helmet. One of these suits, size medium regular, was available for the centrifuge program.

**FIGURE 3: SECOND PROTOTYPE APOLLO
PHASE B SUIT-UNPRESSURIZED**

In the course of the program, it was found that the longer-trunked men sat several inches too high with respect to the instrument panel. (This can be seen in a comparison of figs. 3 and 5.) The medium regular phase B suits were too small for these pilots and, therefore, the ILC "state-of-the-art" suit had to be utilized. (See fig. 5.) Even though the helmet vision restriction with this suit was not nearly as pronounced as it was with the phase B suit, it required one or more inches of headpad insert to see the instrument panel when the suit was unpressurized. The vision lines for the ILC suit are shown in figure 20.

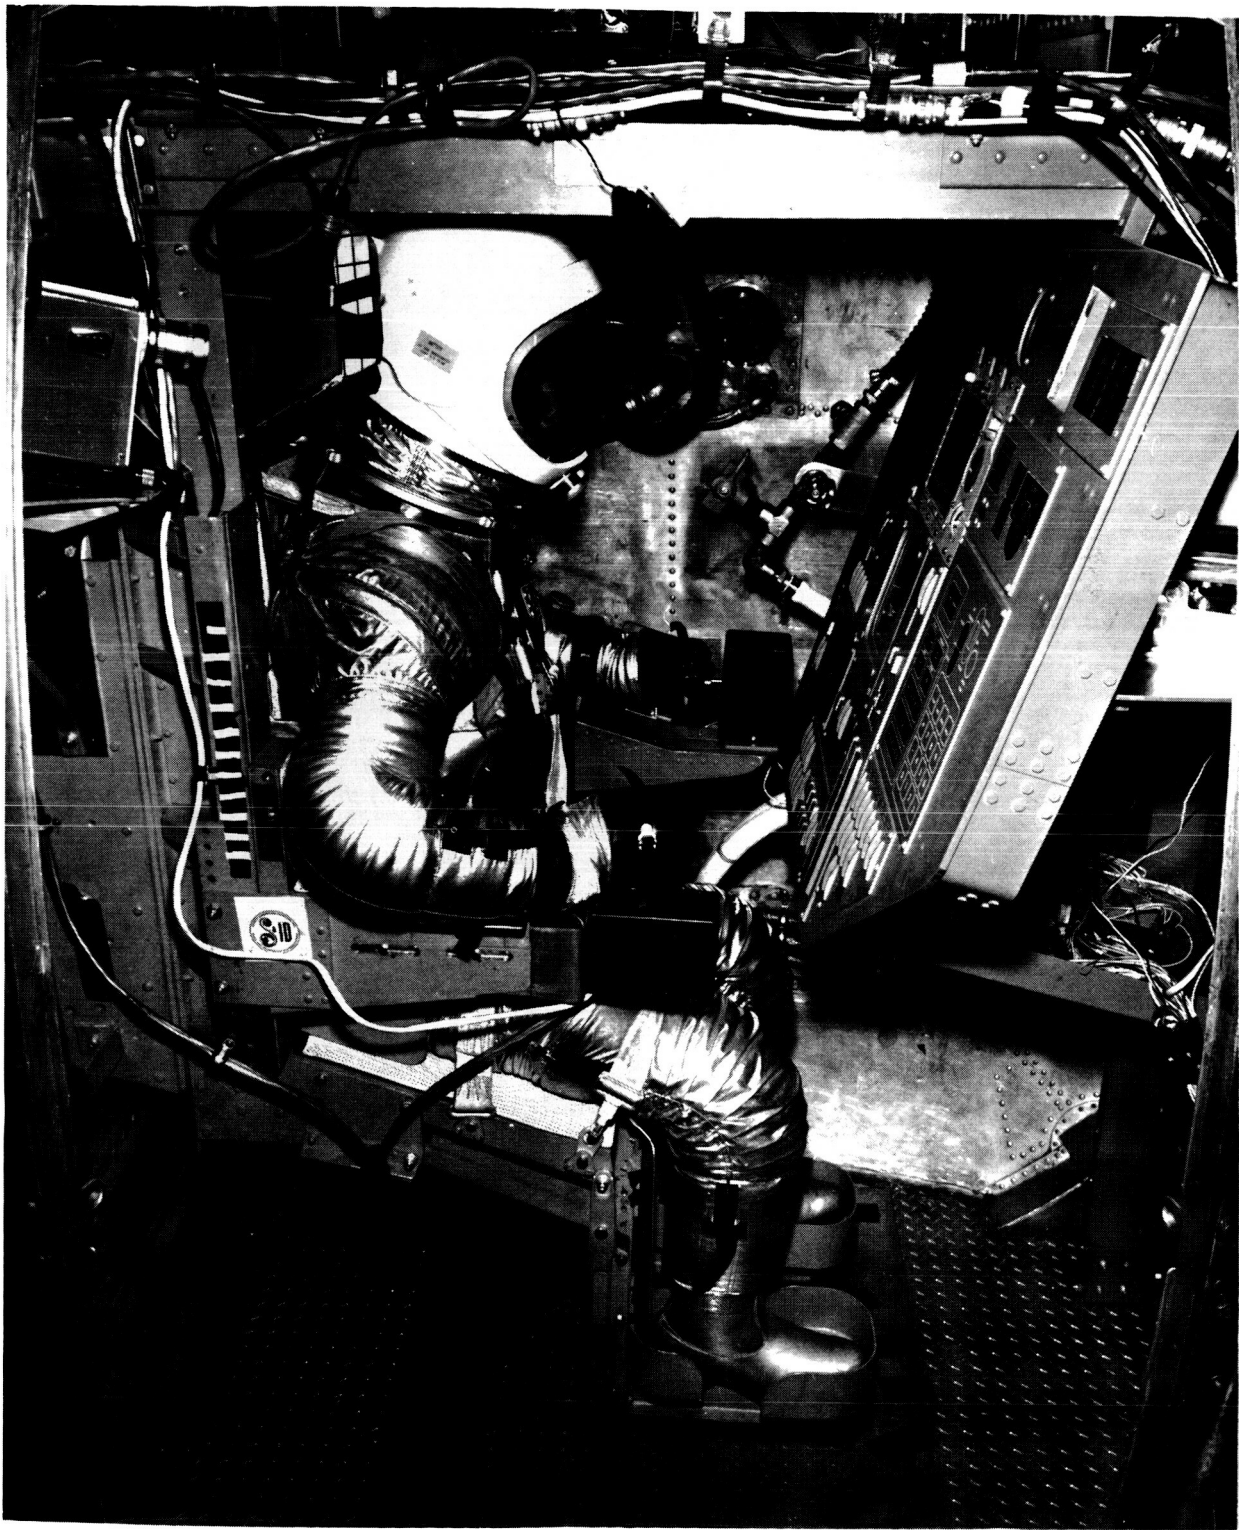
**FIGURE 4: SECOND PROTOTYPE APOLLO
PHASE B SUIT—PRESSURIZED**

The second prototype Apollo phase B suit proved to be totally unsatisfactory. It was impossible for some pilots to get their arms into the armrests. This was primarily because of the shoulder design in the suit. A major suit modification is required to integrate the arms with the armrests. When the phase B suit was pressurized, the neutral position of the forearms was 6 inches to the side and 10 inches forward. When the arms were forced back into the armrests, the wrist rings caused pressure points, wires across the back of the arms caused pressure points, and pressure points existed inside the elbows. The pilot unknowingly held full left roll, pitch up was not attainable, and the stick could not be gripped for yaw control due to suit restrictions.

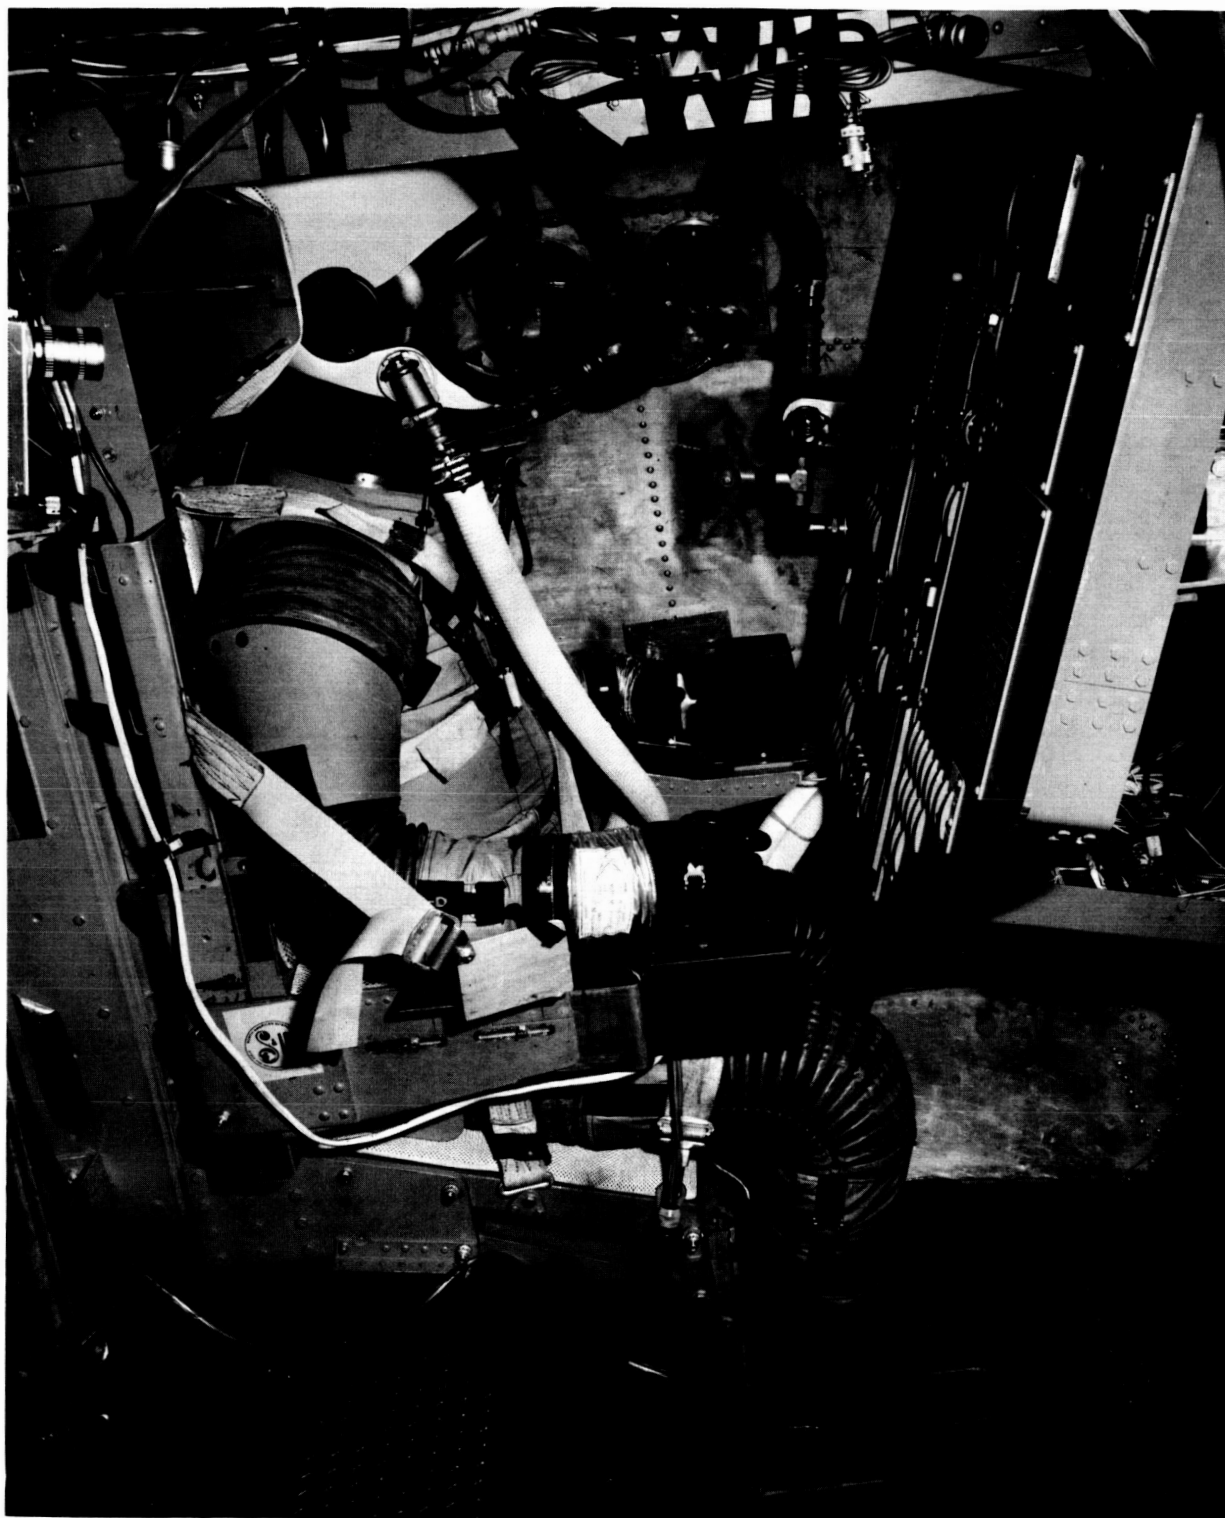
A Gemini pressure suit was used for one day in order to make some comparison runs. A fourth suit, the International Latex "state-of-the-art" suit (fig. 5), was worn by the astronauts who could not fit into the Apollo phase B suit. Since the "state-of-the-art" suit was the forerunner of the Apollo suit, it had some similarity, especially in the arms, shoulders, and gloves. The major difference was in the helmet.

**FIGURE 5: INTERNATIONAL LATEX CORP.
"STATE-OF-THE-ART" SUIT — UNPRESSURIZED**
